Report No.:18290KC30075601

Test Report

Product Name : LED landscape light

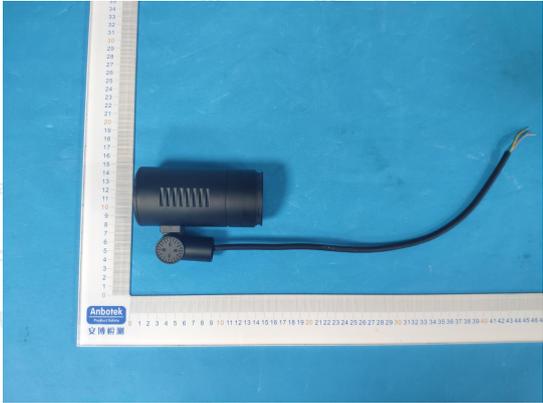
Before test		Test set-up

1. IK08				
Test Standard	IEC 62262:2021			
Test Condition	--- the sample is Installed on the rigid support surface, Begin the impact test from a height of 300 mm using the pendulum 1.7 kg, The energy of impact test specimens for 5J; --- The impact of 5 points evenly distributed in the front metal surface of the sample; --- There shall be no more than three collisions applied near the same position of the enclosure; ---Test times of each part: 1 time. --- Check the sample after the test.			
Test Equipment	Equipment Name	Equipment No.	Equipment model	Equipment Cal validity period
	IK impact tester	SE-1459	GRPH-2	2024.2.19
Test requirements	The sample is allowed to be slightly cracked, dented and not to be seriously damaged.			
Test Result	Sample No.	Test Result		Evaluation
	18290KC300756 -1-1-1	After the test, the sample has no crack or dent.		Pass
Photos
